# Manhole Inspection Summary

Manhole # S17A1\_014MH

Insp Date: **6/13/08 10:00 AM**

**Location** Address: **2701 wilmington av**

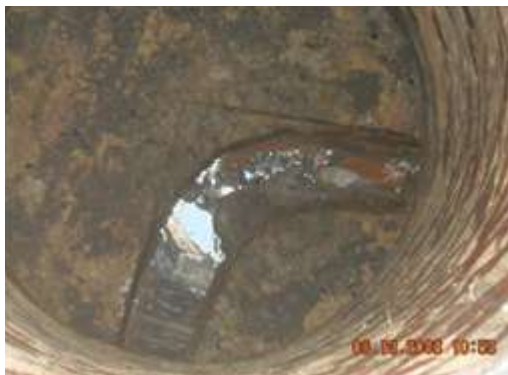
misc

debris in channel

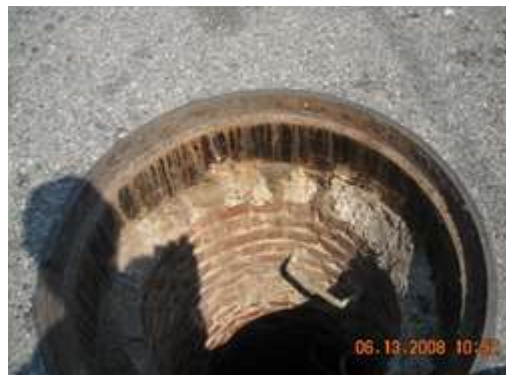
Misc (Inflow Evidence)

Subject To Ponding: **Sheeting**

☒ **Leaks**

Frame inflow - evidence from sheeting

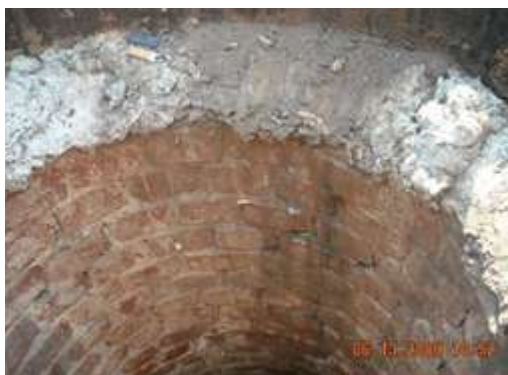
Defect 4

Infiltration: ☐ None ☒ **Joint** ☐ Cracks ☐ Mortar ☐ Roots ☐ Wall

infiltration @ chimney/frame joint

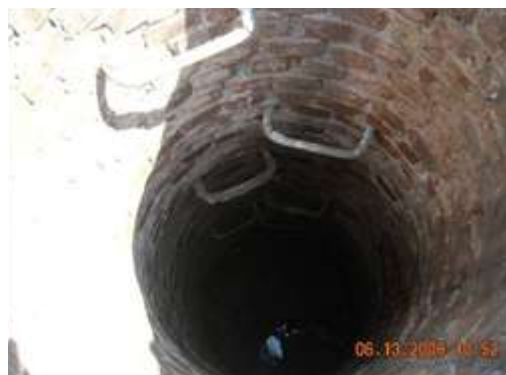
Defect 3

Count: **8** Missing: **0** ☒ **Corroded**

corroded steps

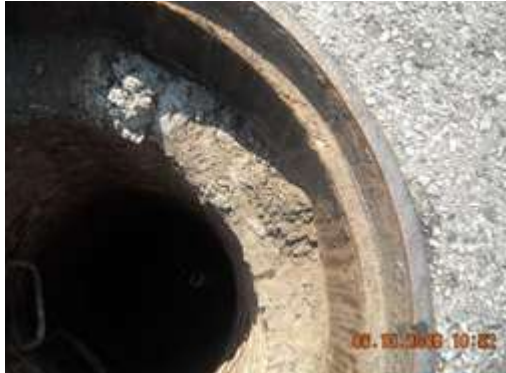
Defect 1

Offset: **3** (in.)

frame offset

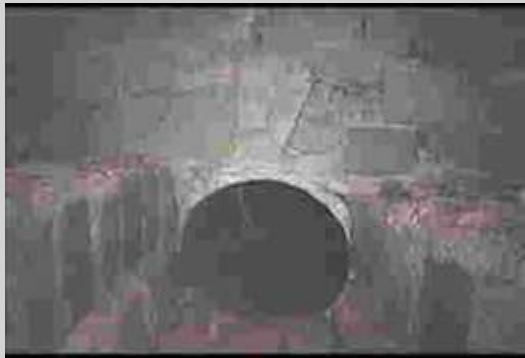
12 O'Clock Outflow

8 in. Circular Gravity Sewer  
Pipe Out @ 12 O'Clock

Pipe Height: **8.4** (in.) Rod and Bar (Angled)  
Pipe Material: **Clay** ☐ Pipe Lined  
Invert Depth: **14.80** (ft.) Flow Characteristics: **Slow**  
Deposits: ☒ None ☐ Mud ☐ Sludge ☐ Debris ☐ Grease  
Silt Depth: **0** (in.) Deposits Extent:  
Infiltration: **None** Pipe Seal Cond: **Sound**

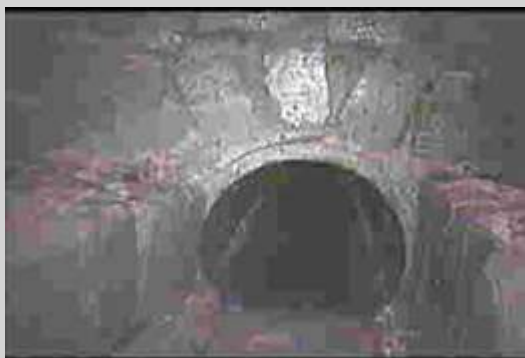
3 O'Clock Inflow

8 in. Circular Gravity Sewer  
Pipe In @ 3 O'Clock

Pipe Height: **8.4** (in.) Rod and Bar (Angled)  
Pipe Material: **Clay** ☐ Pipe Lined  
Invert Depth: **14.69** (ft.) Flow Characteristics: **Slow**  
Deposits: ☒ None ☐ Mud ☐ Sludge ☐ Debris ☐ Grease  
Silt Depth: **0** (in.) Deposits Extent:  
Infiltration: **None** Pipe Seal Cond: **Sound**
